TEST REPORT

SLIP RESISTANCE MEASUREMENT OF
EXISTING PEDESTRIAN SURFACES

University of Sunshine Coast

28-01-2020

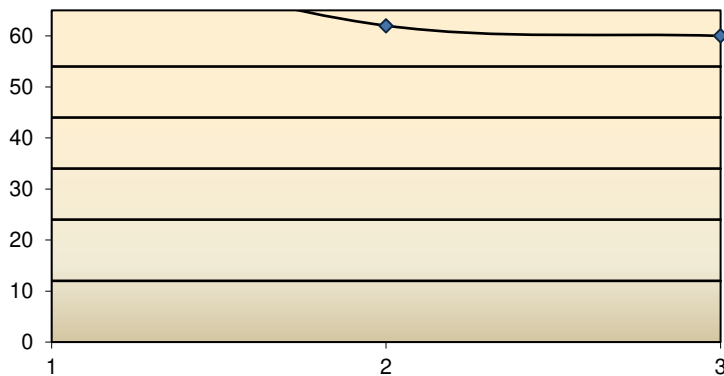
Test Location	Surface Type	Surface Coating	Surface Conditions	Slider Conditioning	British Pendulum Number (BPN)	Slip Resistance Value & Slope Correction Value	TEST RESULTS (Slider96)
Test Area 7. Carpark 11A entrance sample #6 - MMR two coats grit 13	bitumen	light green coating	environment: external (uncovered area) slope: <1.5 degrees surface: textured test direction: anticipated pedestrian travel other observations: n/a	P400	77	(SRV)	Mean BPN result after adjustments 77
				87	84	77	
					82		
				lapping	75	(SCV)	
				63	65	n/a	
Test Area 8. Carpark 11A entrance sample #7 - Street bond matt urathane	bitumen	beige coating	environment: external (uncovered area) slope: <1.5 degrees surface: textured test direction: anticipated pedestrian travel other observations: n/a	P400	58	(SRV)	Mean BPN result after adjustments 62
				82	68	62	
					63		
				lapping	60	(SCV)	
				64	59	n/a	
Test Area 9. Carpark 11A entrance sample #8 - Street bond poly 85	bitumen	beige coating	environment: external (uncovered area) slope: <1.5 degrees surface: textured test direction: anticipated pedestrian travel other observations: n/a	P400	62	(SRV)	Mean BPN result after adjustments 60

84	60	60	
					59		
				lapping	59	(SCV)	
				64	60	n/a

Temperature: 30 deg.C
 Weather: Overcast
 Surface Cleaning: Tested as found
